# **Summerset II Homeowner's Association**

## **2026 Budget Plan & Pavement Maintenance Report**

**193 Summerset Dr, Brentwood, CA 94513**

# Summerset II - 2026 Budget Plan – Urgent Level Repairs

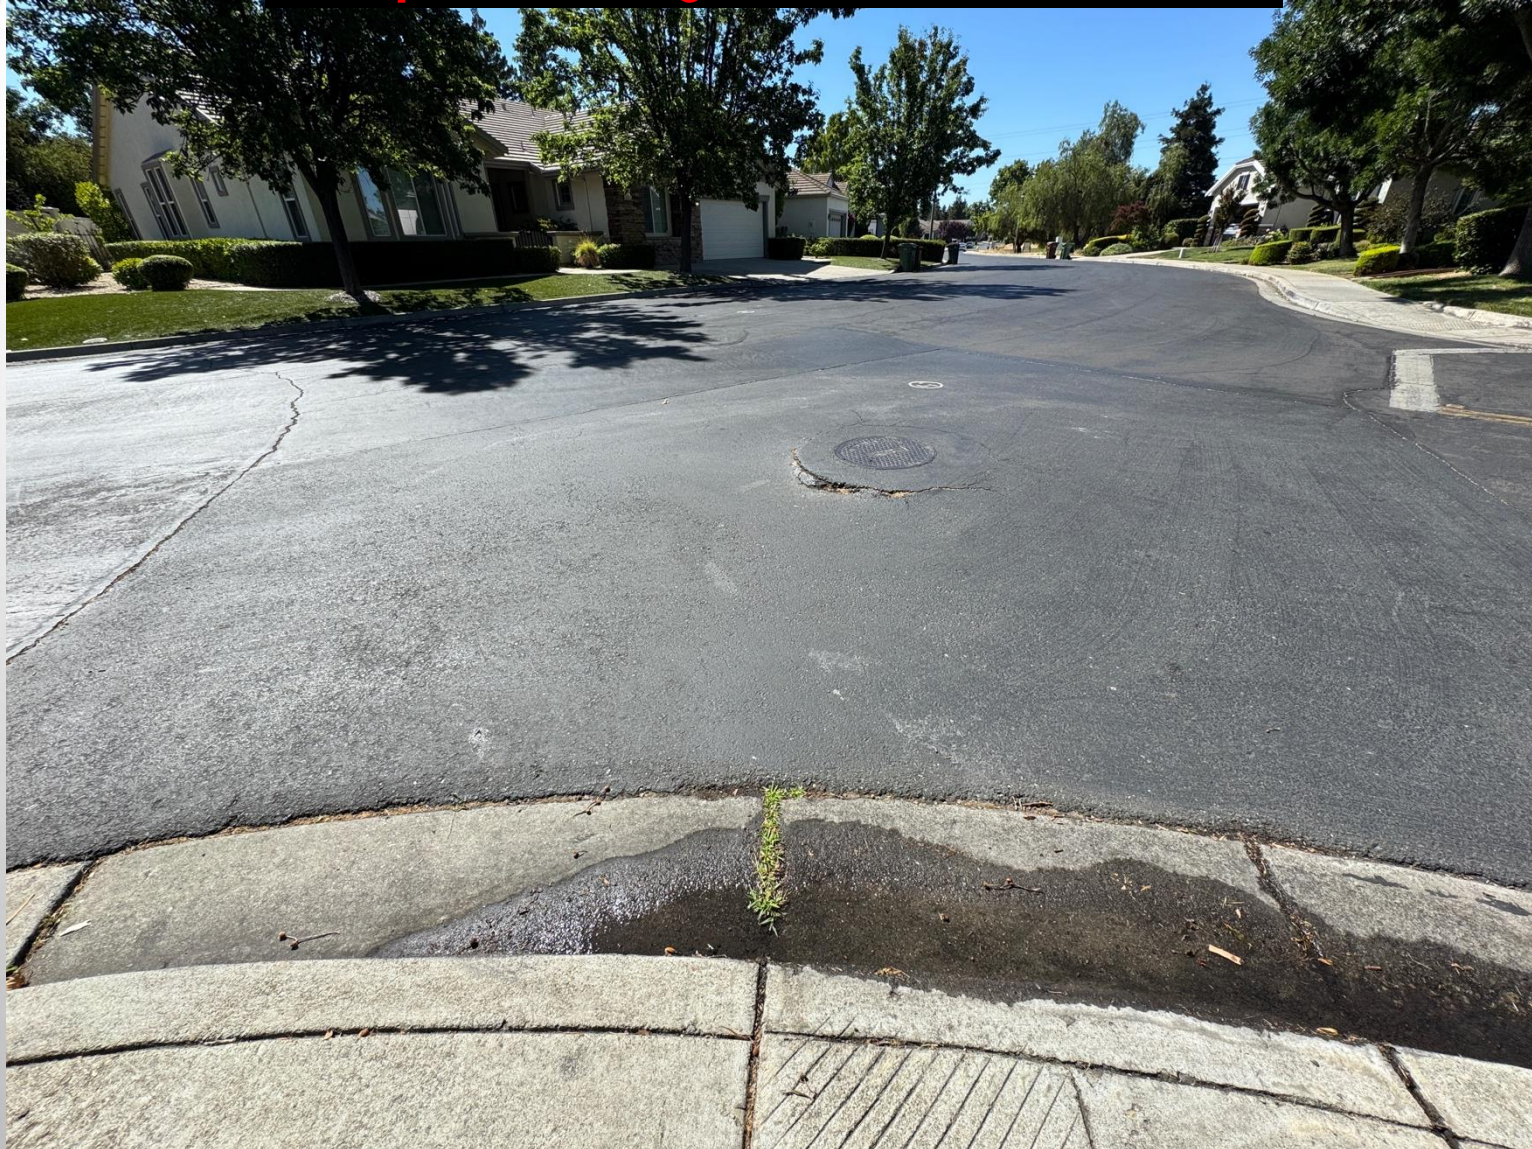
### Examples of designated Red Conditions...

- These areas need replacement “as soon as able”.

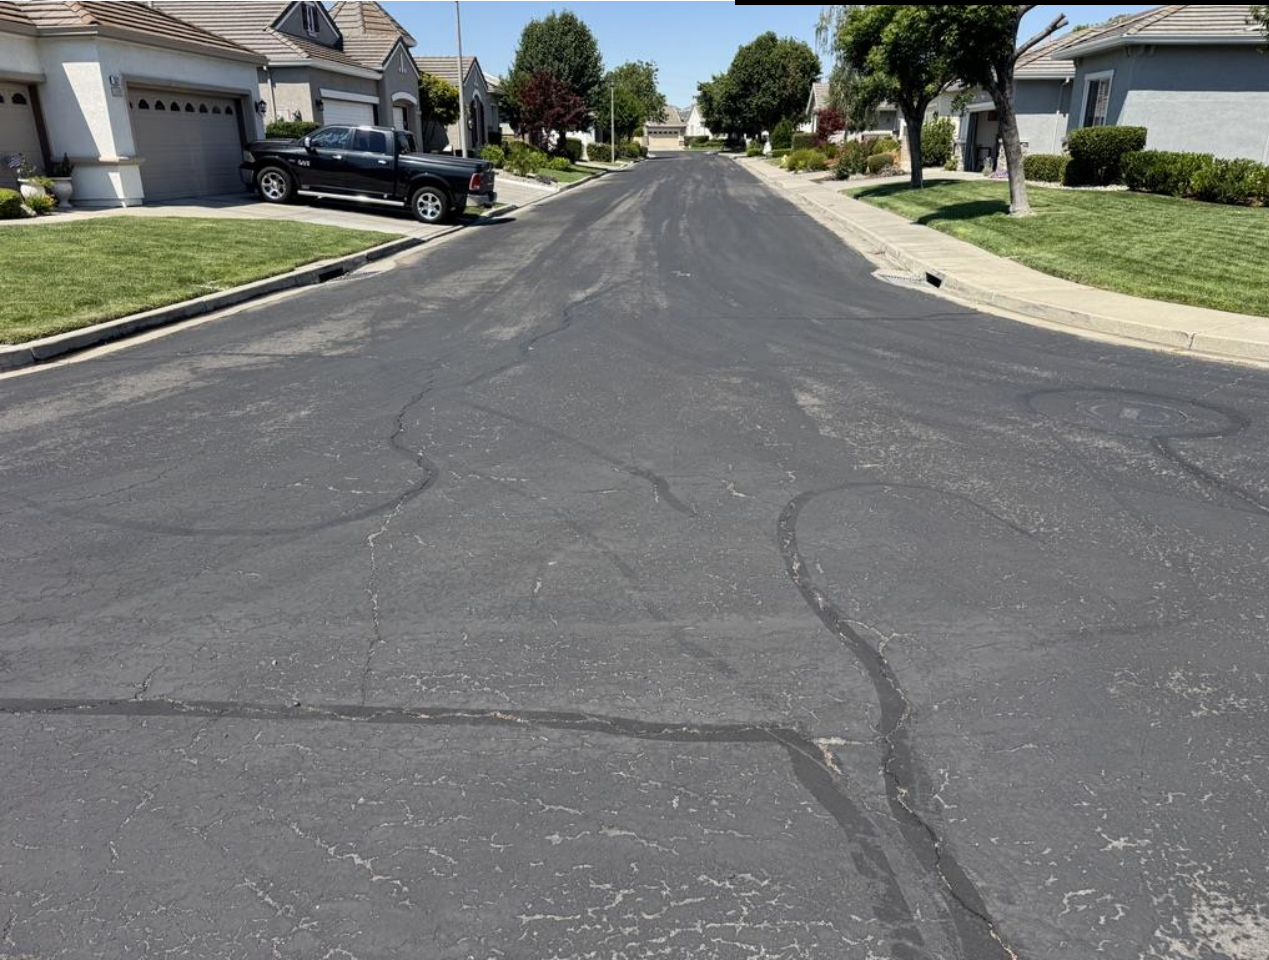
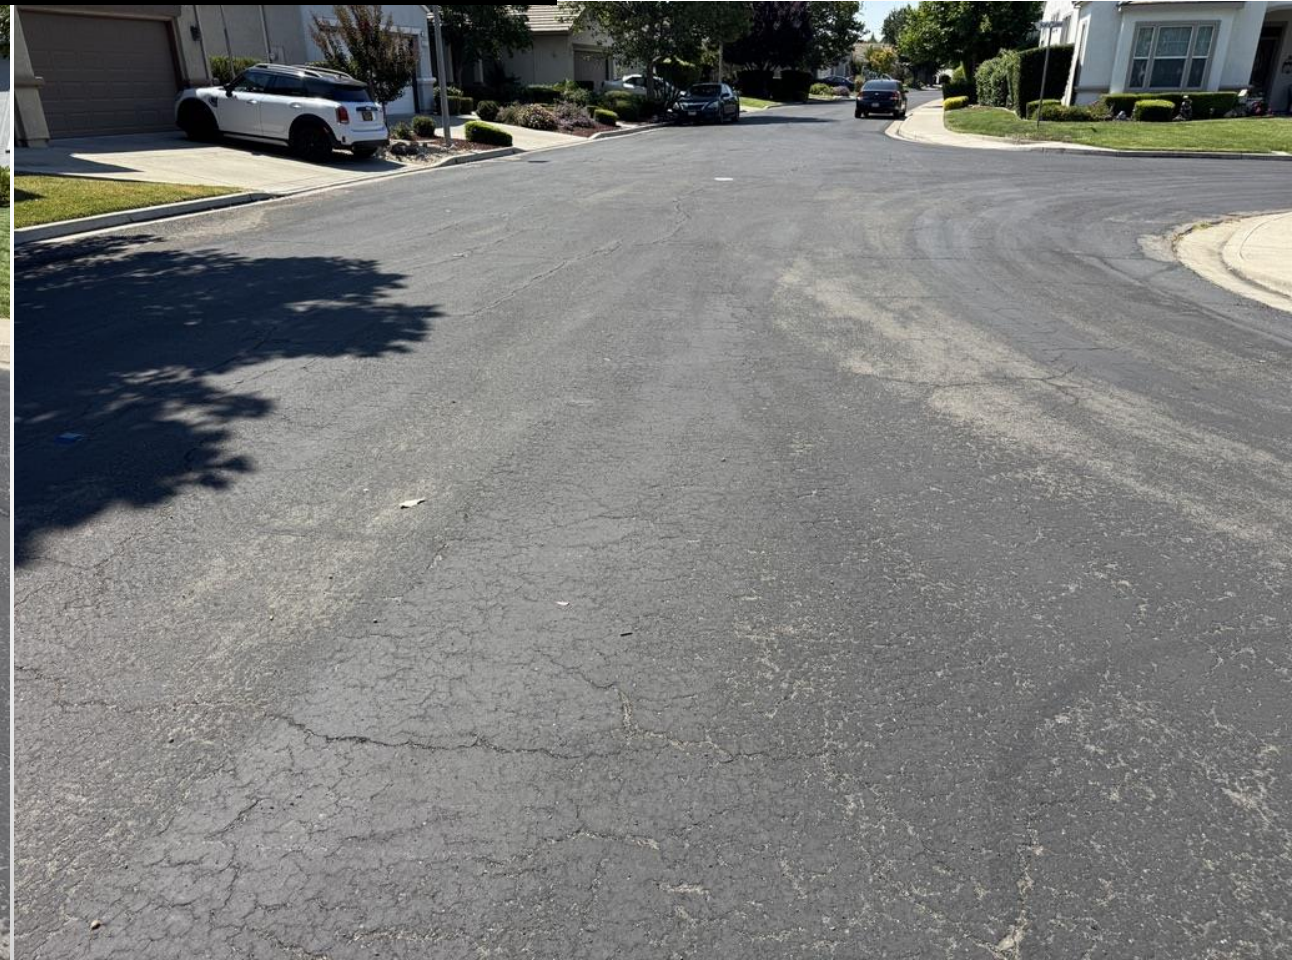
## Examples of designated Yellow Conditions...

- These locations (many) will have various levels of “useful life remaining”
